MICROSCOPIC INVESTIGATION OF INTERFACE
CORROSION OF STEEL-ALUMINUM EXPLOSIVELY
BONDED MATERIAL EXPOSED TO
PERIODIC SEA WATER SPRAY

THESIS

September 1976

20. ABSTRACT (Continue on reverse side if necessary and identify by block number) An explosively bonded triclاد consisting of 5456 aluminum, 1100 aluminum, and ASTM A516, Grade 55 steel is currently in use as a transition joint between steel hulls and aluminum superstructures on several military marine vehicles. This study examines some of the corrosion processes and product formations that take place when this joint is exposed to the marine atmosphere. Accelerated sea spray testing was performed

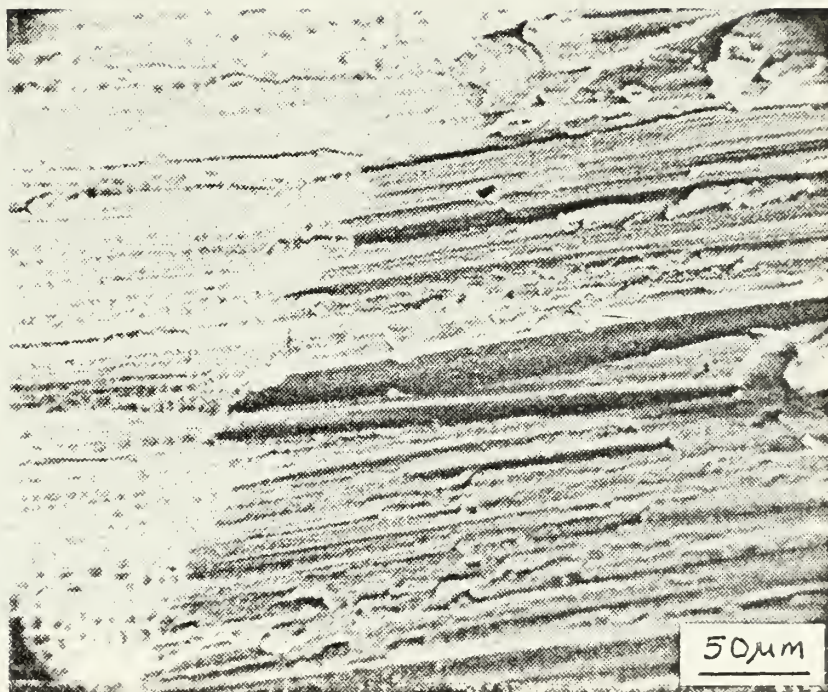
Figure 49. 280x SEM picture of the bond interface area after 12-hour exposure (Steel \longleftrightarrow Al).

the aluminum were beginning to grow. Surface features, though still generally recognizable, were becoming far less distinct. Figures 49 and 50 show the bond areas at different magnifications. The scale formations of alumina were still not apparent at 240x after 12 hours even though the surface appears to be covered, Figure 51. At 2400x the by now familiar dried-and-checked-paint appearance again can be seen, Figure 52. On the steel side of the samples, the alumina film appears to have formed a nearly continuous coating over the entire surface, Figure 53, with interspersed appendages of iron oxide. Figures 54, 55 and 56 show that the alumina film actually exists right up to and perhaps underneath the rust particles. The rust may have formed prior to the alumina film, or broken through the cracks after the film had formed.

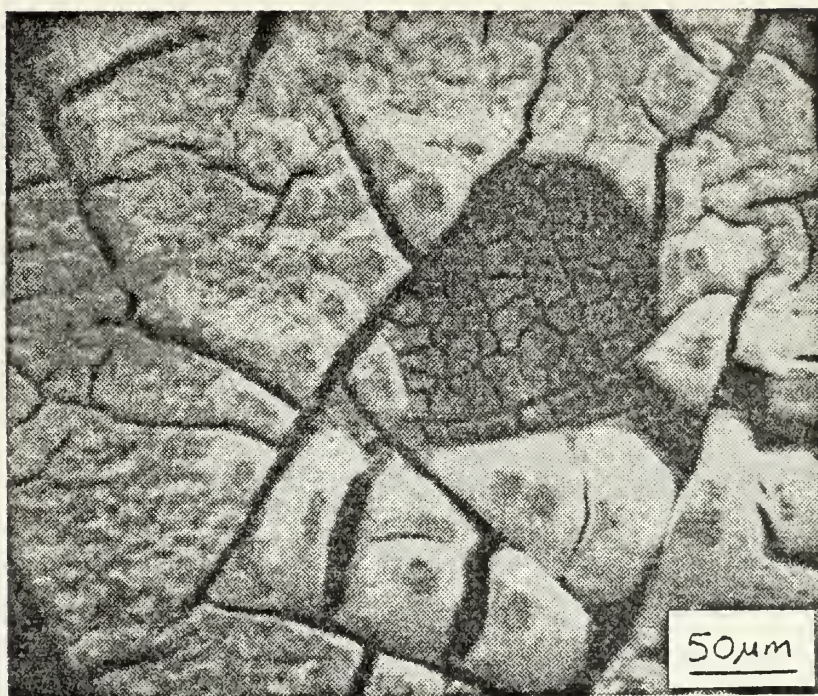
Figure 63. 280x SEM picture of alumina layer beneath second corrosion product film on five-week exposure sample (Steel surface).
